# Gedempte Zuiderdiep 62

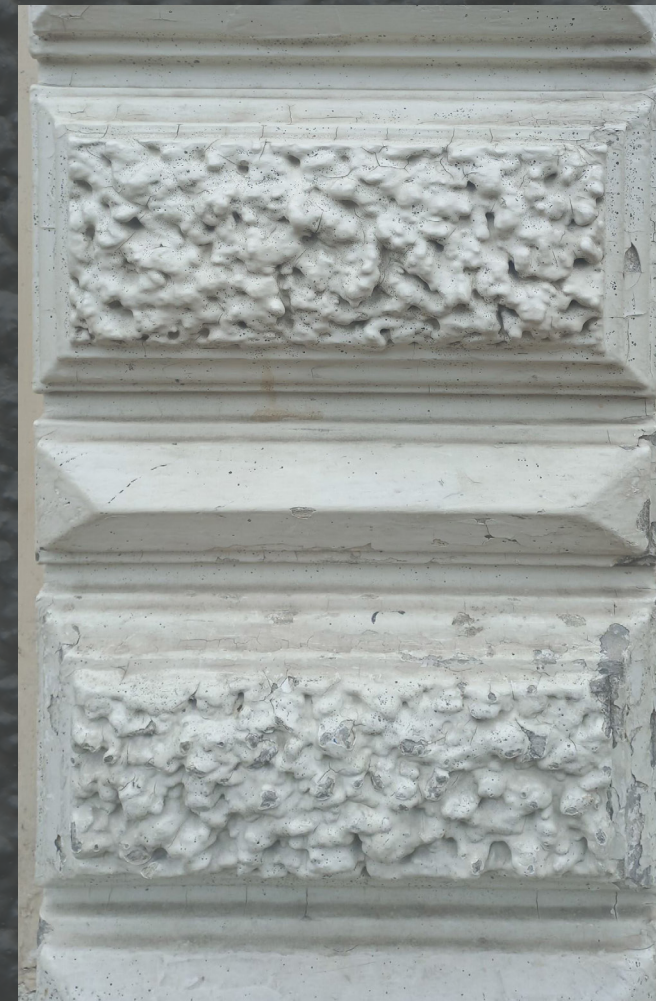
Façade coated with stucco (plaster), shaped to imitate stone blocks, (rustication). The rough, bubbly panels were created by pressing or sculpting the wet plaster to produce an irregular, organic texture. This type of decorative work was common in late 19th to early 20th

century European architecture (around 1880–1910), often influenced by eclectic or early Art Nouveau styles. Over time, weathering and repainting have softened the surface, giving it its worn appearance.

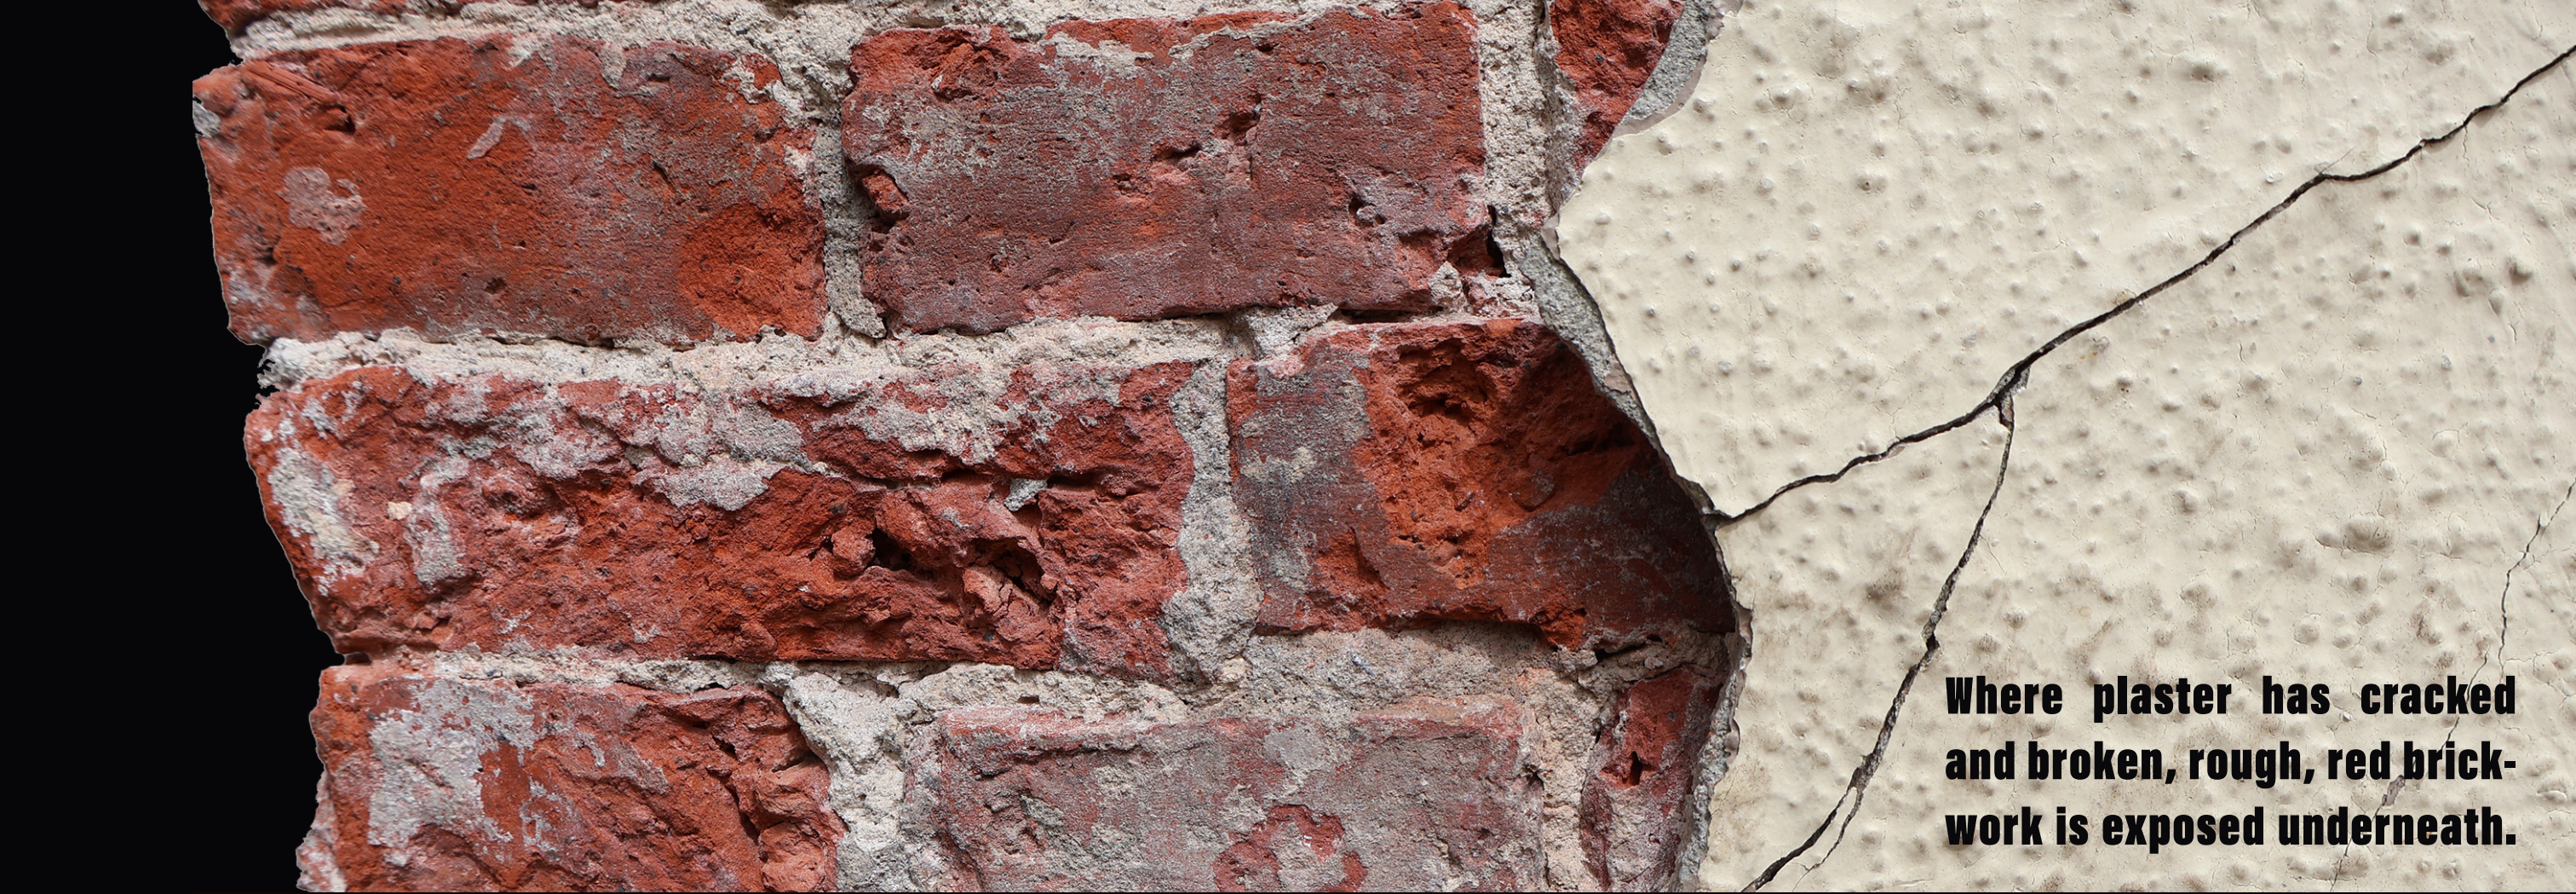
**BROKEN**

A close-up photograph of a wall. On the left, there is a section of red brickwork with visible mortar joints. To the right, a layer of light-colored, textured plaster is cracked and peeling away, revealing the brick underneath. A prominent crack runs diagonally across the plaster. The overall appearance is one of age and wear.

**Where plaster has cracked  
and broken, rough, red brick-  
work is exposed underneath.**
