Gedempte Zuiderdiep 62

COARSE
PROUGHT
WEATHERED
STULCO 1660

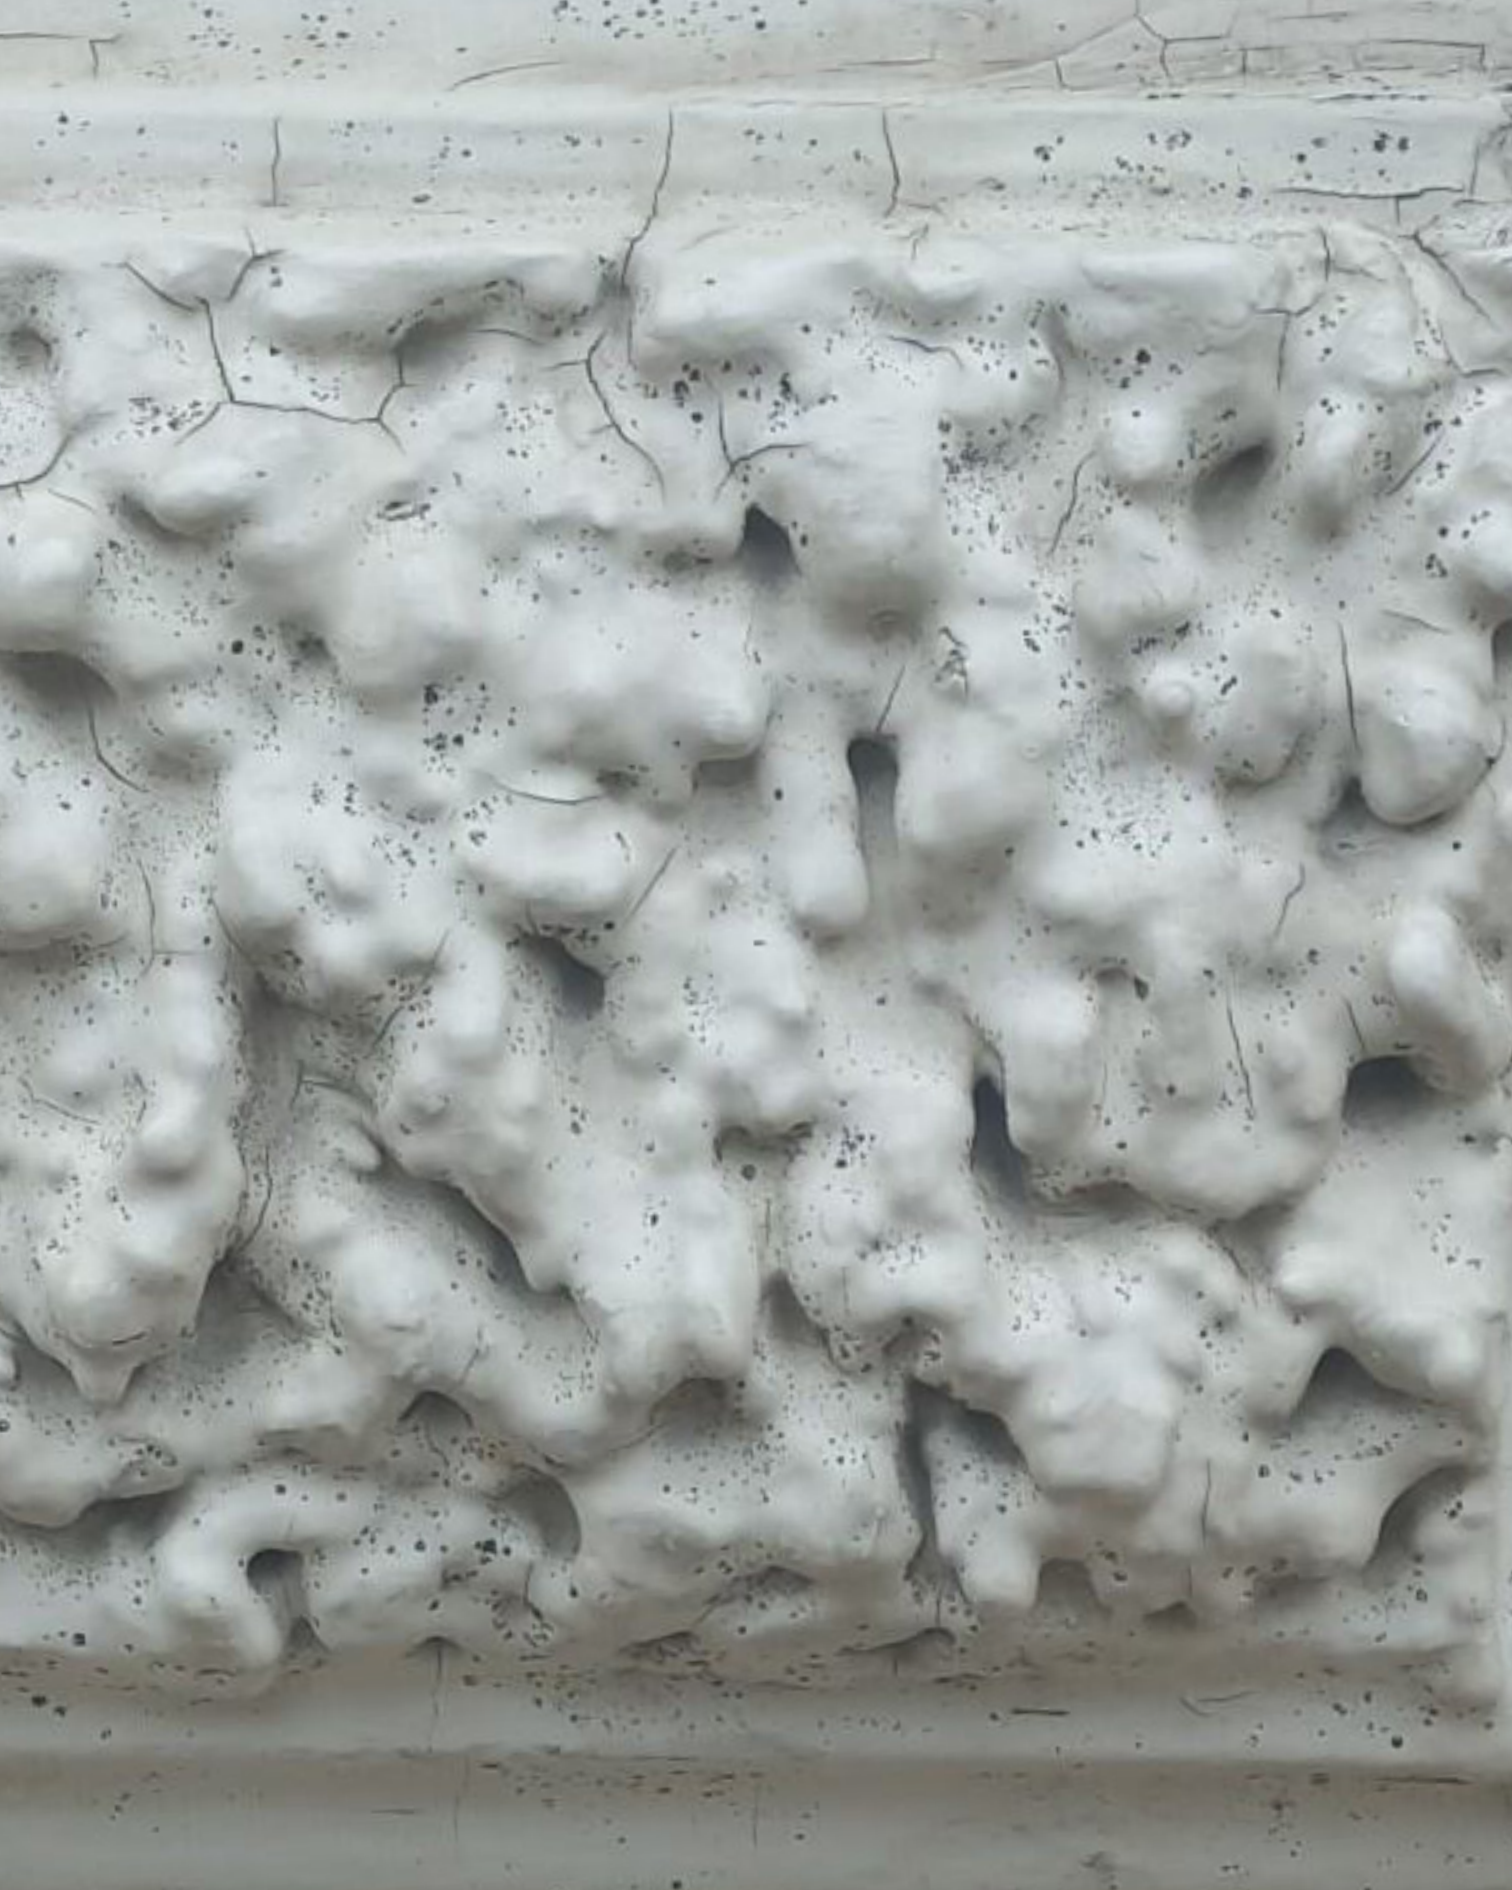
Façade coated with stucco (plaster), shaped to imitate stone blocks, (rustication). The rough, bubbly panels were created by pressing or sculpting the wet plaster to produce an irregular, organic texture. This type of decorative work was common in late 19th to early 20th

century European architecture (around 1880–1910), often influenced by eclectic or early Art Nouveau styles. Over time, weathering and repainting have softened the surface, giving it its worn appearance.
